# L&A Home Inspections

## Home Inspection Report

**1234 Main St**

Inspected on Sun, Feb 2 2014 at 3:01 PM

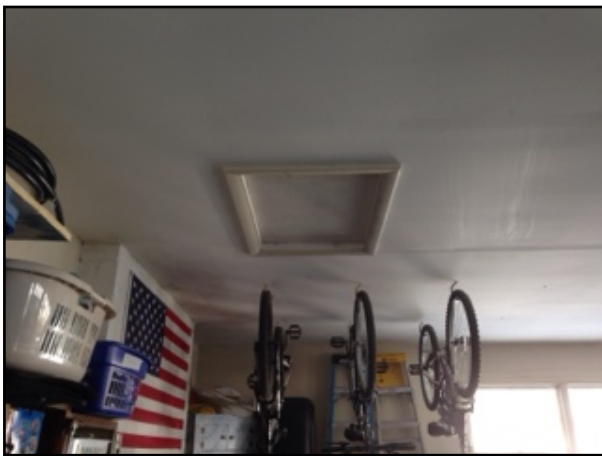
Figure 10-1

The attic was inspected from the access hatch only since there is blown-in insulation and the ceiling joists cannot be seen to walk on without damaging or compressing the insulation which reduces it's R value.

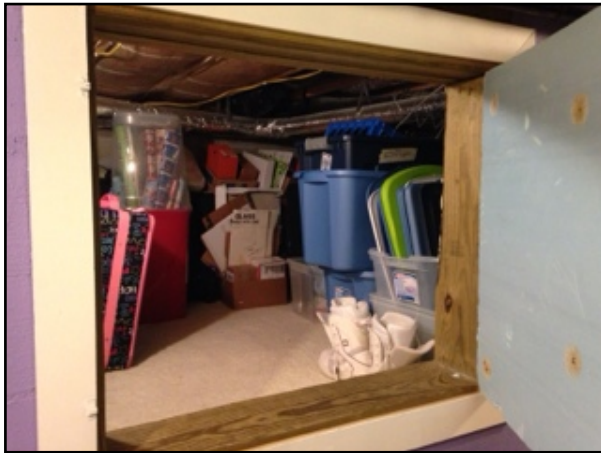
Figure 13-1

The crawlspace was full of storage material so it was not inspected. From the parts that I could see the pipes are insulated, the duct runs are insulated, however the bat insulation is installed upside down between the joists. The warm side is where the paper on the batt should be placed. The vapor retarder in the crawl space is the concrete itself.

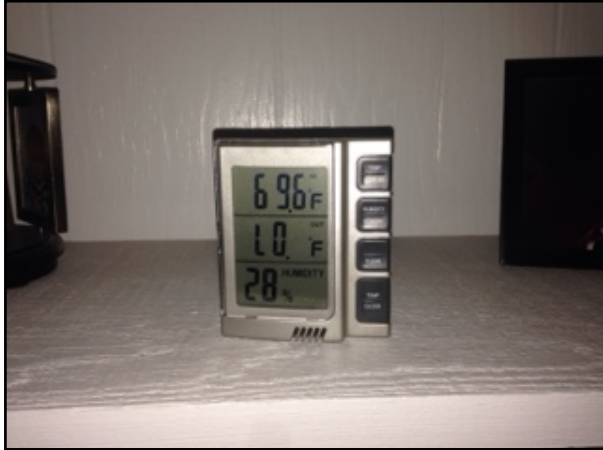
Figure 14-1

The owner has an hygrometer in the basement which is reading at 28% humidity. This is satisfactory.

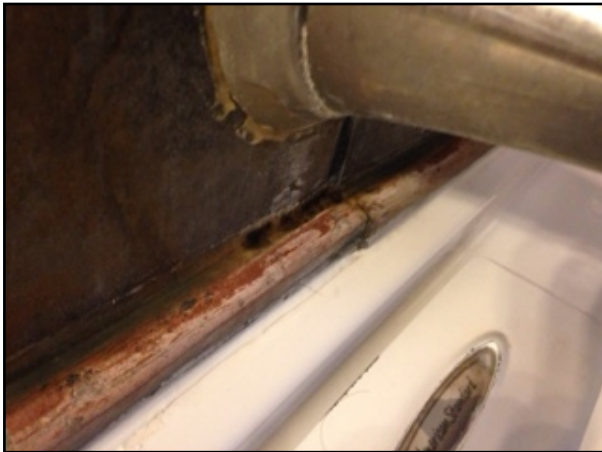
Figure 23-1

Caulking shows signs of wear. Will need to make sure and replace or maintain the caulking to avoid any water penetration.

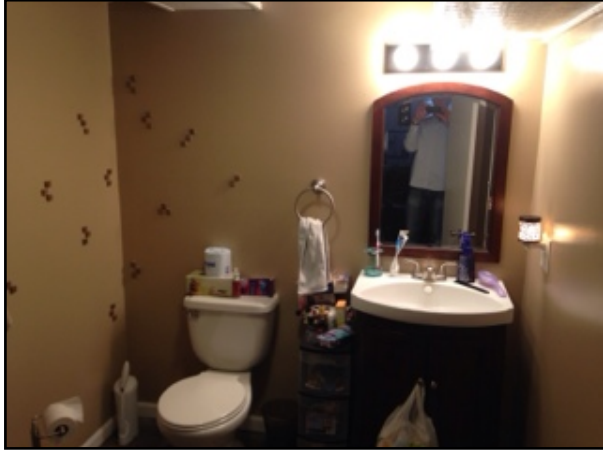
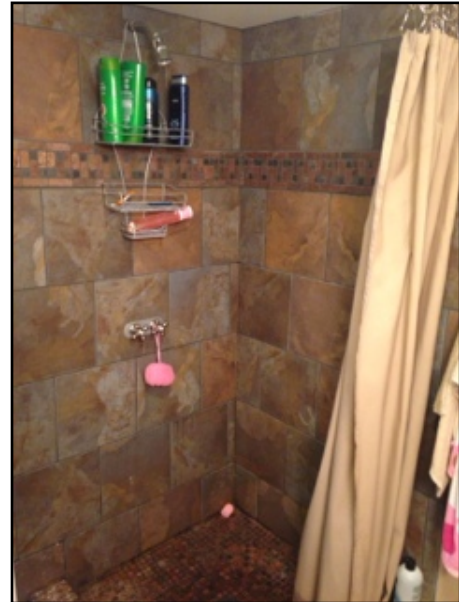
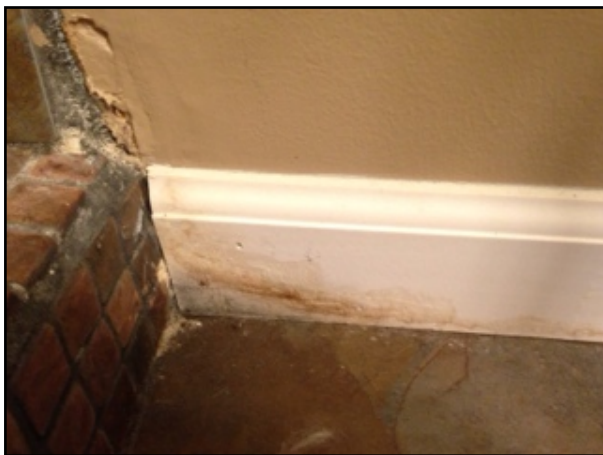
By the edge of the shower in the basement bathroom shows signs of moisture damage. You may want to consider painting this and keeping an eye on the moisture levels in the bathroom. Also make sure to dry the tile next to the baseboard after showering to prevent any mold issues.

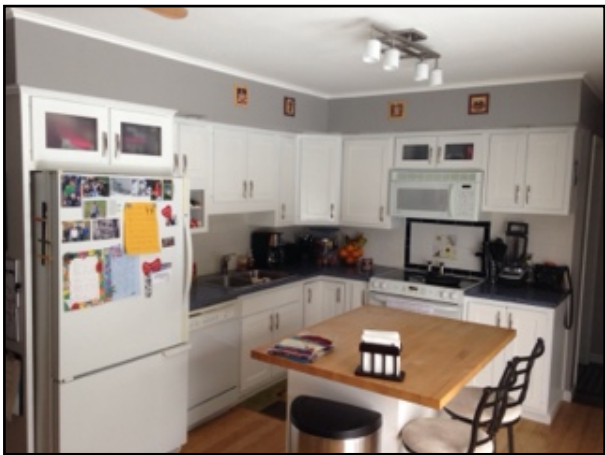
Figure 30-1

**Comment 30:**  
A home inspection does not include checking the appliances to make sure they are working and within manufactures tolerances. I did however check to make sure the burners got hot and the oven begins to heat. The magnetron in the microwave is working, the refrigerator is cold as well as the freezer, and the garbage disposal runs. The dishwasher remains untested.

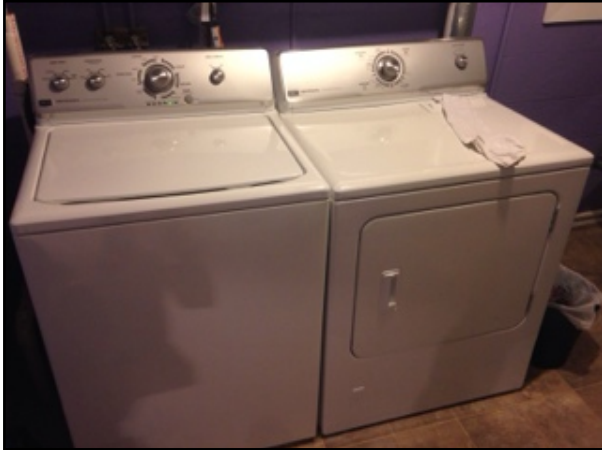
Figure 31-1

I listed the washer and dryer as satisfactory condition. However please remember that we do not turn on these units to make sure that they are working properly.

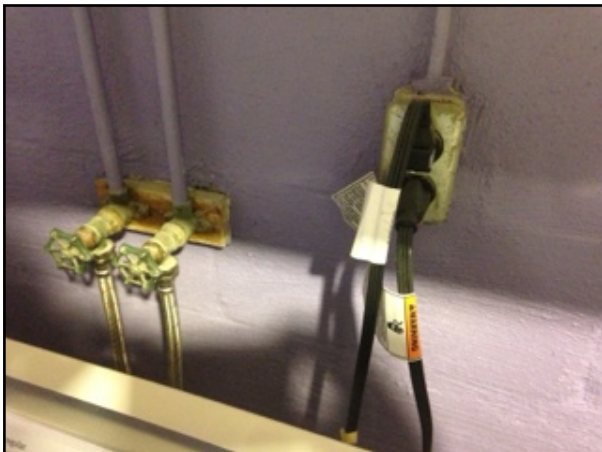
Figure 32-1

A GFCI, also known as a ground fault circuit interrupter outlet is recommended for the washer and dryer since they are right next to the water supply lines.

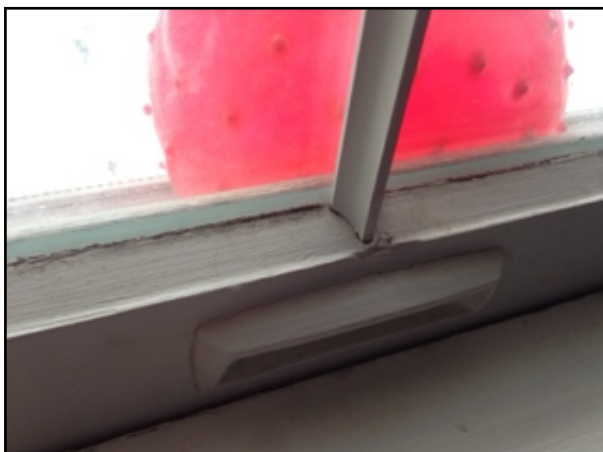
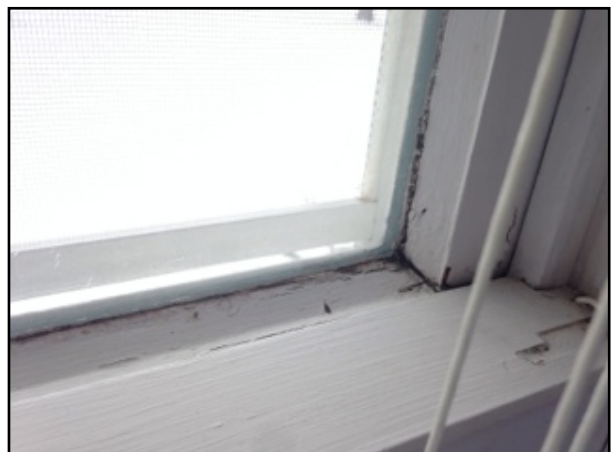
The floors have normal wear and tear. Some minor scratches but overall in good condition.

The window wood frame in the first bedroom off of the kitchen shows signs of moisture in the past and they need to be painted.

The southwest bedroom window also shows signs of moisture not in between the panes but on the panes making the wood rot. Recommend repainting.

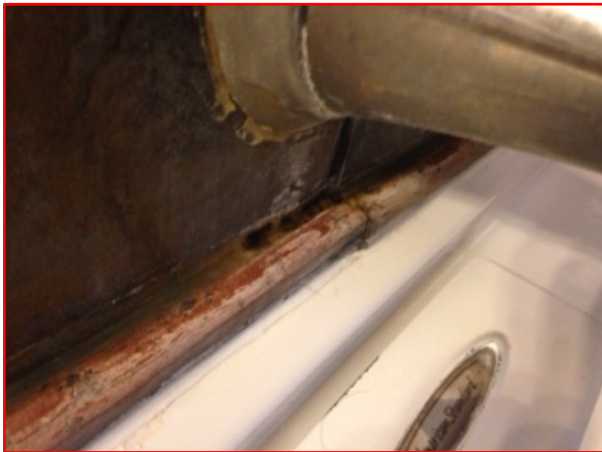
Figure 5-1

5) Caulking shows signs of wear. Will need to make sure and replace or maintain the caulking to avoid any water penetration.

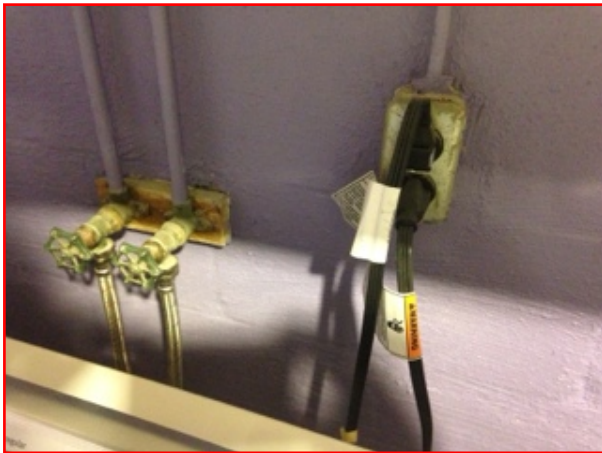
Figure 8-1

8) A GFCI, also known as a ground fault circuit interrupter outlet is recommended for the washer and dryer since they are right next to the water supply lines.

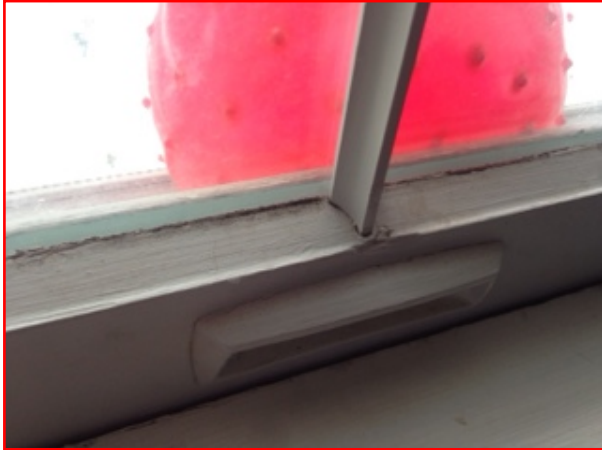
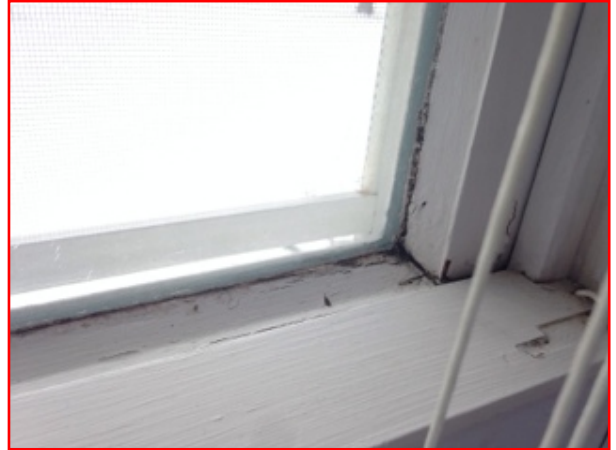
9) The floors have normal wear and tear. Some minor scratches but overall in good condition.

The window wood frame in the first bedroom off of the kitchen shows signs of moisture in the past and they need to be painted.

The southwest bedroom window also shows signs of moisture not in between the panes but on the panes making the wood rot. Recommend repainting.
