# L&A Home Inspections

## Home Inspection Report

**1234 Main St**

Inspected on Sun, Feb 2 2014 at 3:01 PM

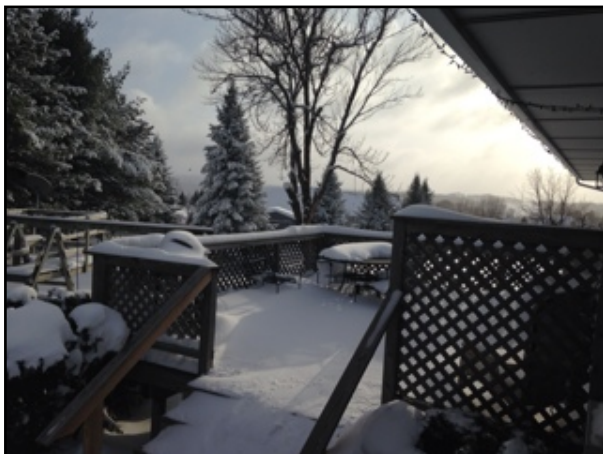
Figure 3-1

The deck although in good condition, will need to be stained again or waterproofed to promote longevity and act as a barrier against water damage and rot.
